Field Inspection Memo

Subject: September 16, 2008, inspection of waterline road

File: Wayne Waters, 5430 Canyon Road, Willits, Mendocino County

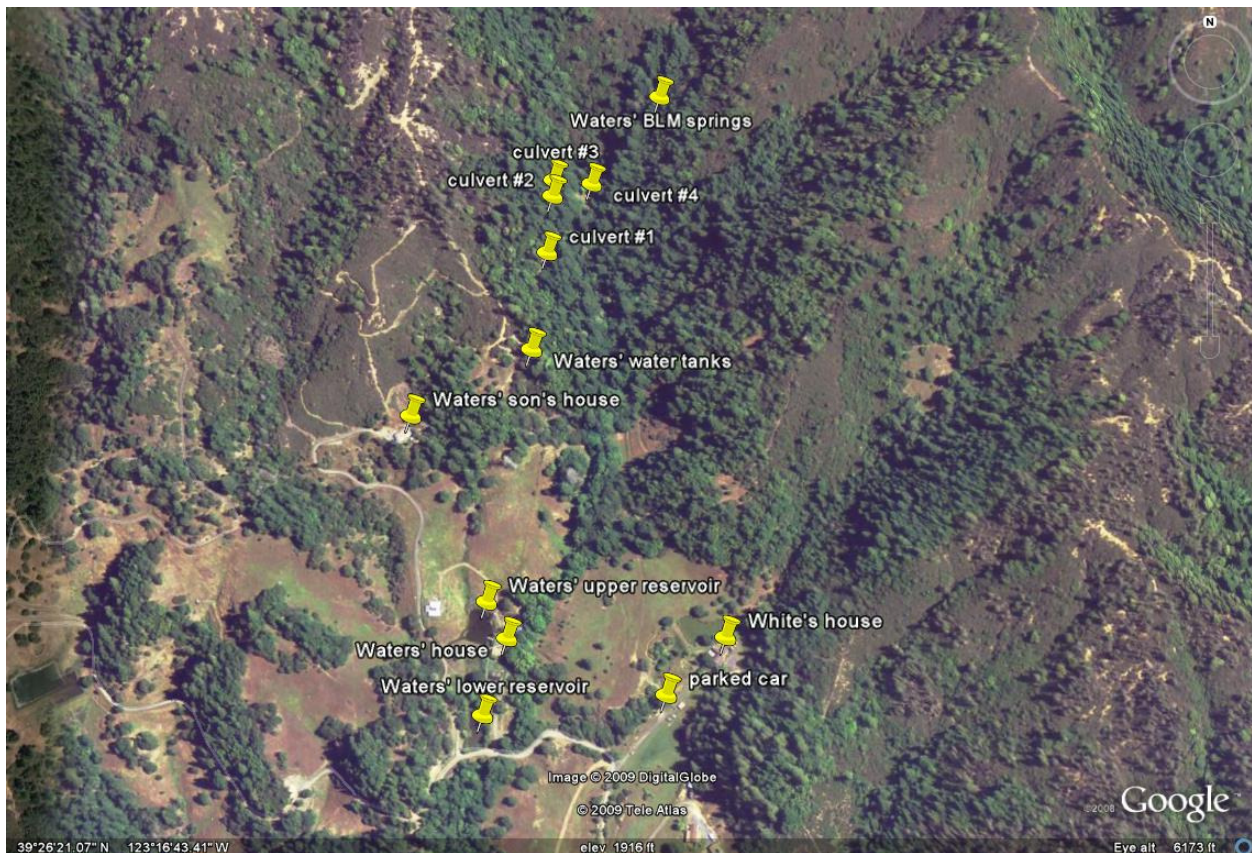
Figure 1. Landmarks and points of interest inspected on September 16, 2008.
